TOWN OF HARWICH HARBORS & MARINE FACILITIES ANALYSIS REPORT

August 19, 2009

Prepared for:
TOWN OF HARWICH
c/o Joe Borgesi, Town Engineer
732 Main St.
Harwich, MA 02645

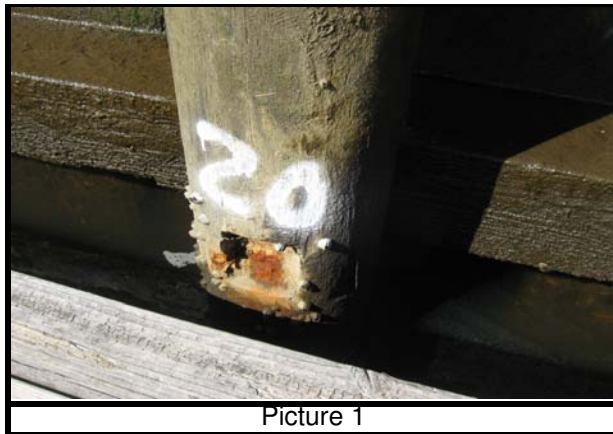
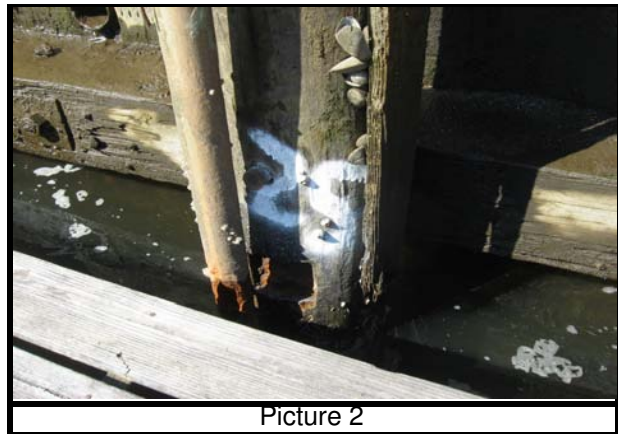
Picture 1

Comments: Piles where dimensions were not obtained: 2x4 side railings should be removed, severe deterioration and rot present, does not appear to serve any function. Also, rotted float guides are recommended for removal @ pile 16 & 25. Overall piles are in good condition.

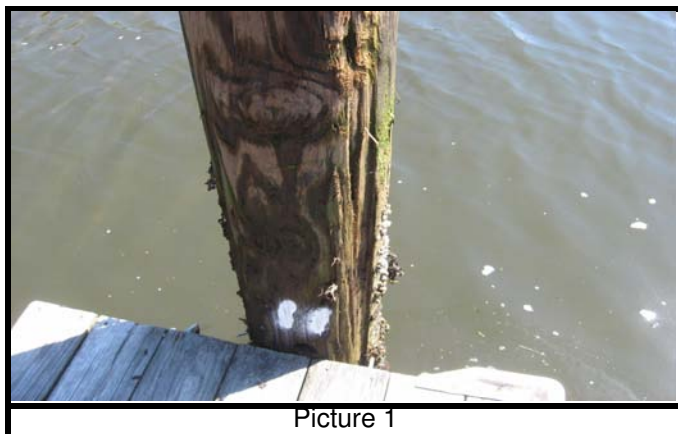
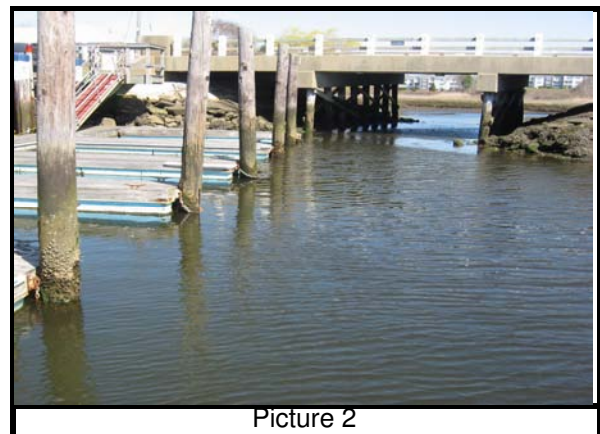
Comments: Piles where dimensions were not obtained: 2x4 side railings should be removed, severe deterioration and rot present, does not appear to serve any function. Also, rotted float guides are recommended for removal @ pile 16 & 25. Overall piles are in good condition.

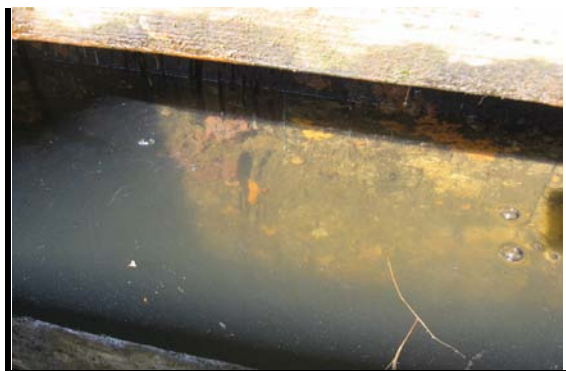
Picture 1

Components of system missing						X		
Rust, corrosion, or bulging present							rust	
<p>Comments: The following comments pertain to large striations and voids in the existing timber bulkhead wall. Majority of holes are caused from rot, as well as marine borers & insect damage. Parking lot above wall has allowed sediment out wash in some parts of wall. 19-21 FT: 2" depth, serious rot @ -1 MLW, 35 FT: 1/2" wide x 1/2" deep, 40 FT: 8" wide x 4" deep, 46-52 FT: substantial deep voids, 47 FT: 100% penetration, 52-71 FT: 3/4" wide x 2" deep marine borer holes uniformly for 19 ft, 72 & 101 FT: 100% penetration, 106 FT: 3"x2" depth, 112-120 FT: major deterioration, washout of substrate due to parking lot slumping, 128 FT: 3"x3" hole -Substantial rust/corrosion of hardware on lower wale (bolt and plate)</p>

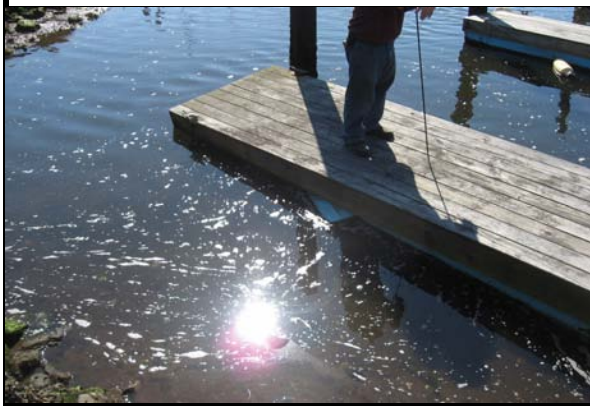
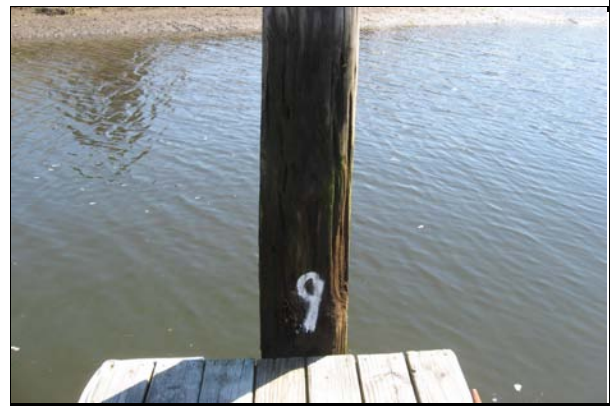
Picture 1

Comments: Overall, floats in fair working condition. Substantial sign of weathering, some loose boards due to disassociated rusted nails. Floatation in many floats is unequal and needs to be assessed. Predicted life of floats is 2-3 years until full replacement. Recommend continued monitoring of loose boards and replacement if safety risk is posed.

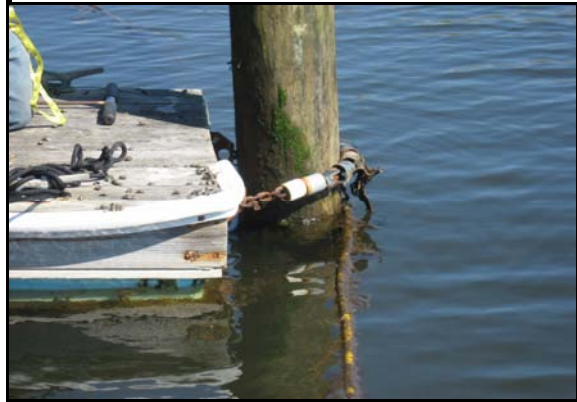
Picture 1

Comments: Some connections to piles are in need of repair. Chains are 100% rusted and are in need of replacement. Floats are in fair condition with moderate to major weathering present. Actual floatation of floats are somewhat uneven due to damaged float drums. Overall in fair condition, no need of immediate action on structural stability of floats.

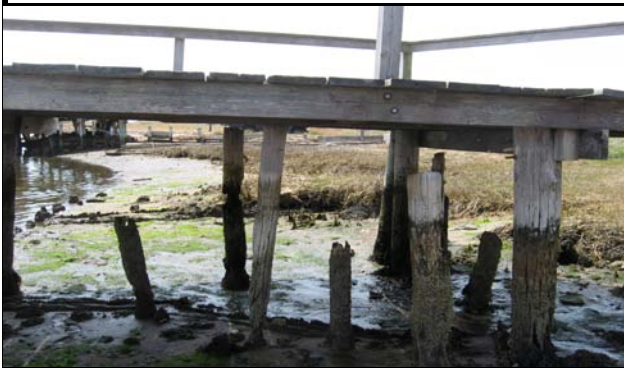
Picture 1

Comments: Overall, pier is in poor condition. Piles have endured major sectional loss from weathering, intertidal wave action, insect and marine borer damage. Connections are not sufficient for structural stability of pier. Majority of structural members are in poor condition, extreme checking and weathering is present. Float and ramp are in fair condition. Recommend that pier be removed and replaced within 1-2 years.

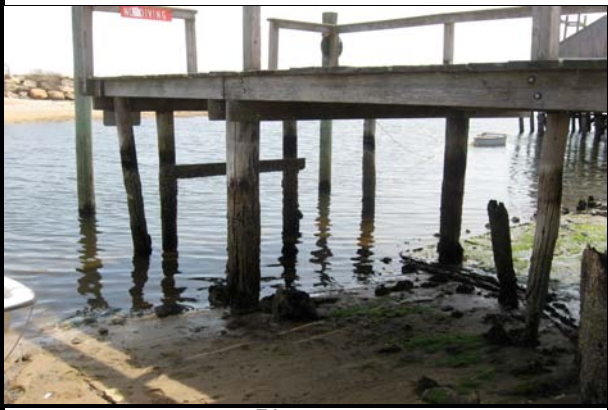
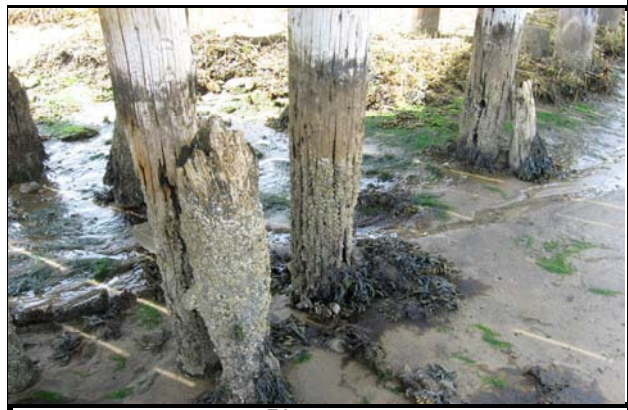
Picture 1

Comments: Pier is in deplorable condition and should be replaced within the next year. Some decking can be salvaged, however, all piles need to be removed and replaced. Connections are not sufficient for load stability, major sectional loss occurring in tidal/splash zone of existing piles. Overall in poor condition.

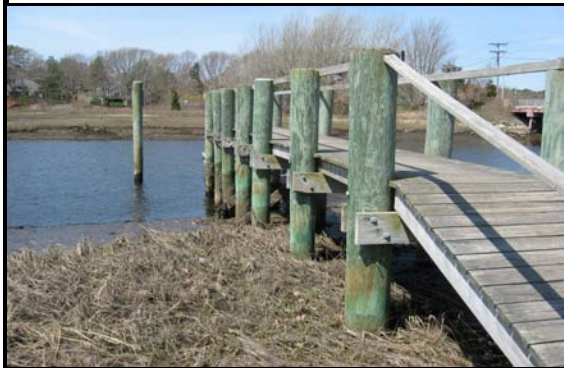
Picture 1

Comments: Pier is in excellent condition. Piles, pier components, and hardware are all in excellent condition and do not require any immediate attention. However, pile caps should be provided for the existing piles. This will ensure adequate protection for the piles in terms of moisture and weathering. Railings are not sufficient for this type of pier, should be installed in accordance with the Massachusetts State Building Code. Float and ramp are in good condition. Float has fabric bumps and 4 cleats that are maintained properly. 3'x3' metal plate at bottom of ramp is in good condition as well.

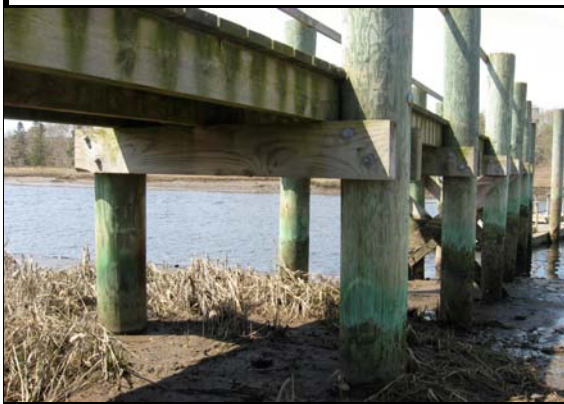
Picture 1

Comments: Pile caps need to be provided to protect pile from accelerated weathering and to prolong its serviceable life. Railings are not sufficient for this type of pier. Need to be installed to code. Otherwise, pier is in excellent condition.

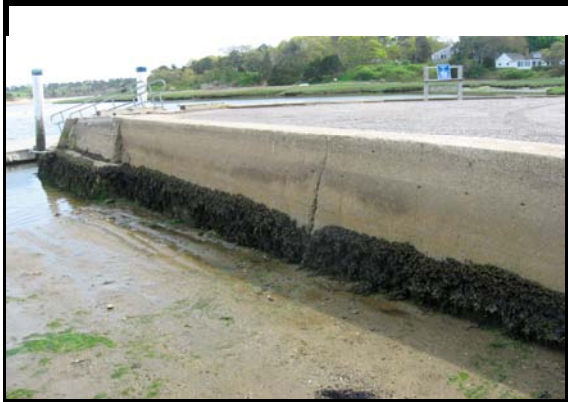
Picture 1

Comments: Original sections of wall adjacent to boat ramp and marsh are in good condition with few sections containing large vertical cracking that penetrates 100% of the wall. Weepholes are present and no evidence of anchors. Area around the float and ramp are in need of repair. Substantial voids in concrete wall along with spalling and horizontal/vertical cracking are present. Voids are causing sediment outfall from parking lot into waterway. Cracking/splitting seems to be caused by lack of expansion joints in concrete.

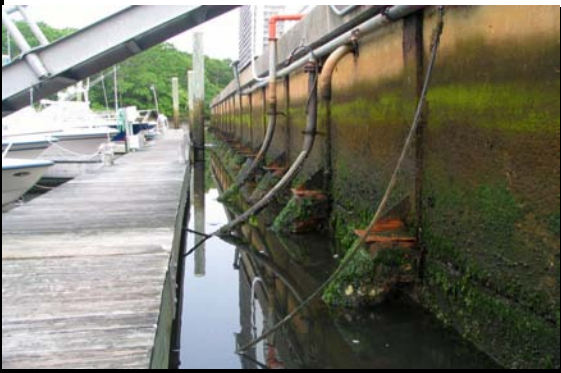
Picture 1

Comments: Piles and compression plates are approx. 8' O.C., two weep holes between all piles, and a few outfalls from adjacent catch basins in the parking lot. All metal compression plates are rusted and corroded, piles in fair to poor condition. Efflorescence present with moderate sediment loss from the above parking lot. H-Piles exposed on parking lot side through cap in various locations. Majority of bracket connections and fasteners have no remaining load transfer capacity. Compression plate still functional with moderate corrosion. Corrosion level of H-piles range from moderate to high levels. Some exterior flanges at approx. 80-90% section loss. Signs of spalled concrete and section loss at cap beam at embedded heads of corroded H-piles. Bulkhead at east side of marina adjacent to fuel dock has deadmen tieback (one anchor per H-pile) and has started to rotate toward harbor likely due to overloading by live load traffic behind wall. Concrete bulkhead panels generally in good condition, some with larger single cracks, some with multiple smaller crack patterns.

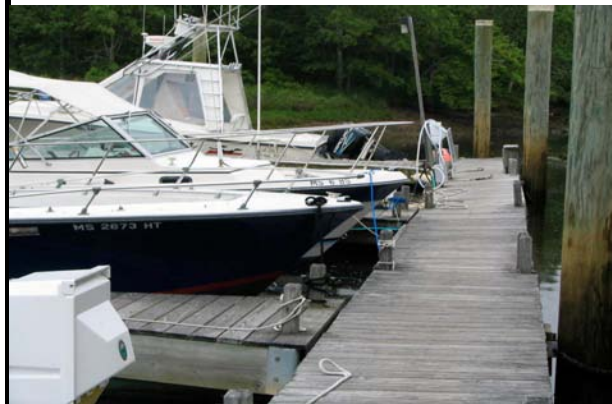
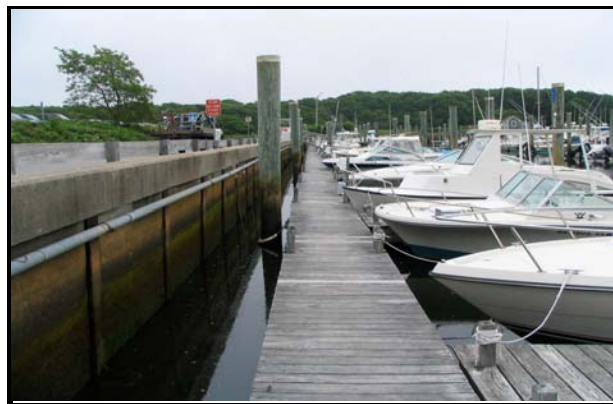
Picture 1

Comments: Brackets are major concern for pile condition. Design/functionality problem - causing major sectional loss in majority of piles. Recommend alternative design/replacement of brackets. Roller configuration seems appropriate.

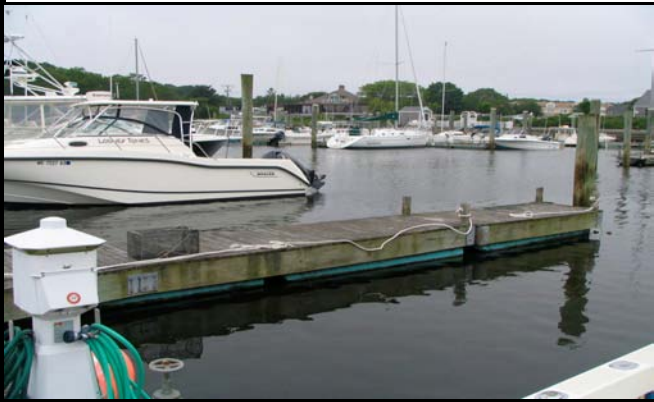
Picture 1

Comments: Brackets are major concern for pile condition. Design/functionality problem - causing major sectional loss in majority of piles. Recommend alternative design/replacement of brackets. Roller configuration seems appropriate.

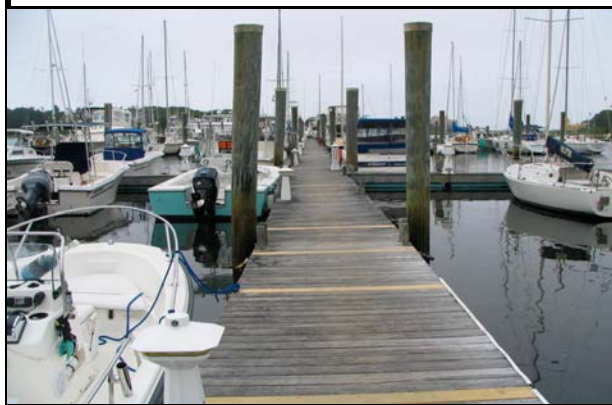
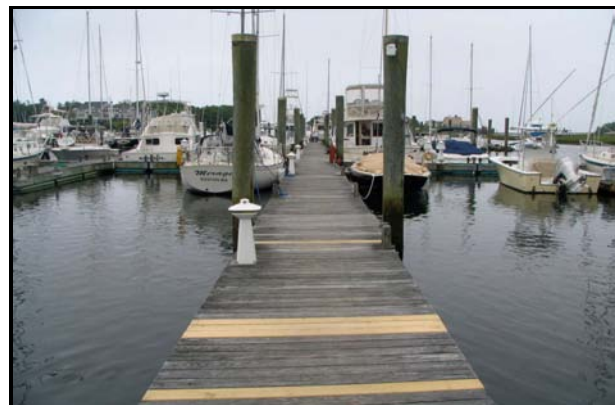
Picture 1

Comments: Brackets are major concern for pile condition. Design/functionality problem - causing major sectional loss in majority of piles. Recommend alternative design/replacement of brackets. Roller configuration seems appropriate.

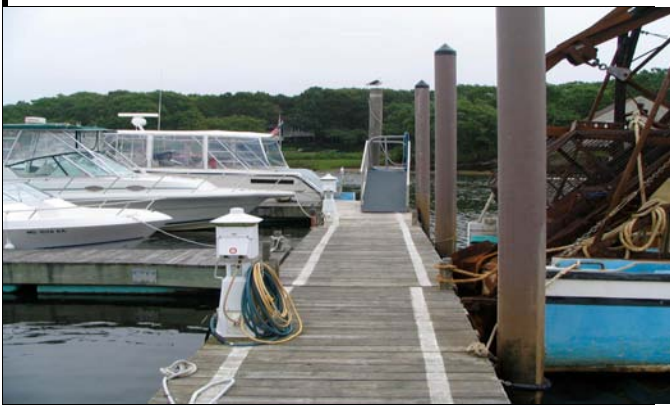
Picture 1

Comments: Brackets are major concern for pile condition. Design/functionality problem - causing major sectional loss in majority of piles. Recommend alternative design/replacement of brackets. Roller configuration seems appropriate.

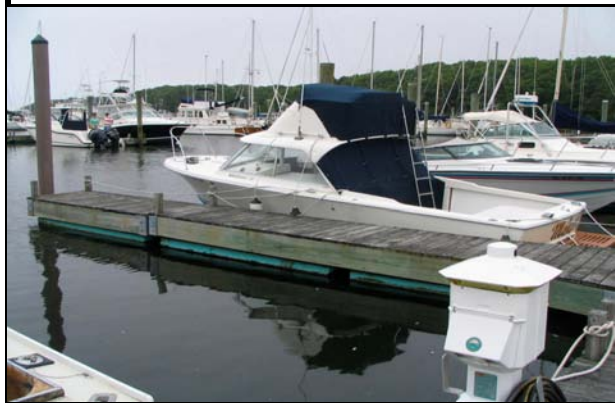
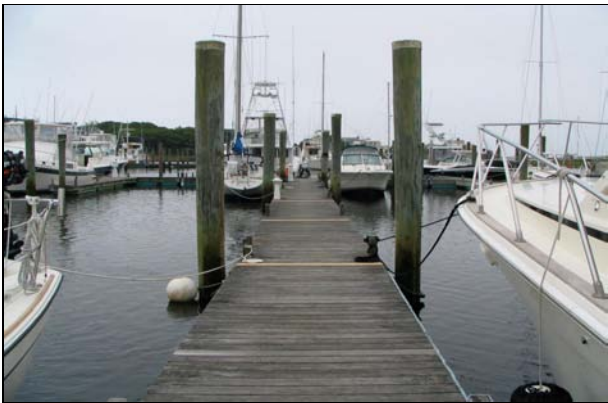
Picture 1

Comments: Brackets are major concern for pile condition. Design/functionality problem - causing major sectional loss in majority of piles. Recommend alternative design/replacement of brackets. Roller configuration seems appropriate.

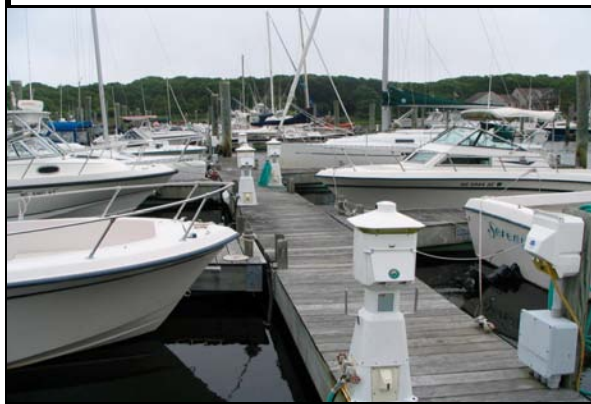
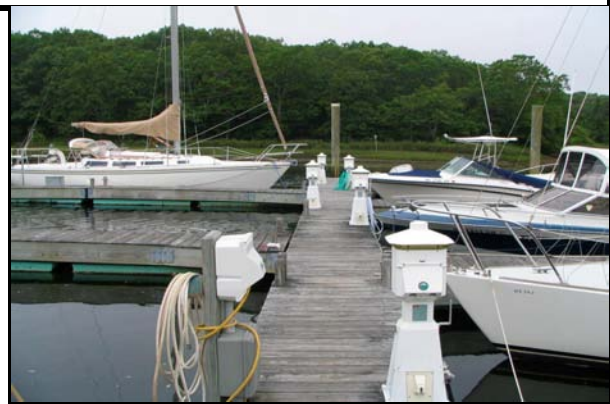
Picture 1

Comments: Majority of floats are in good condition, with a few exceptions that have loose or rusted members. No immediate need for maintenance. Life span approximately 5 years until full replacement

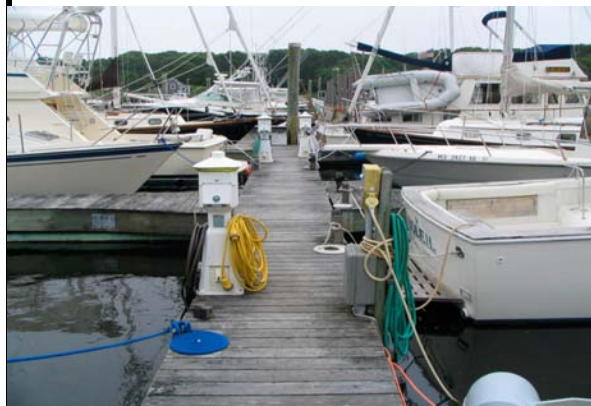
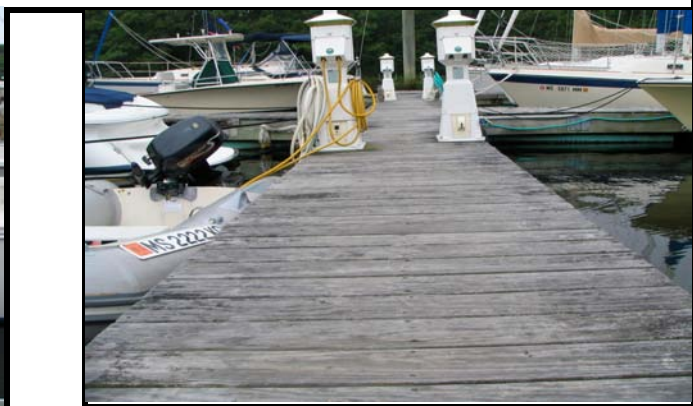
Picture 1

Comments: Loose boards are in need of replacement or proper fastening. Remaining floats have adequate floatation. Life span of floats approximately 5 years.

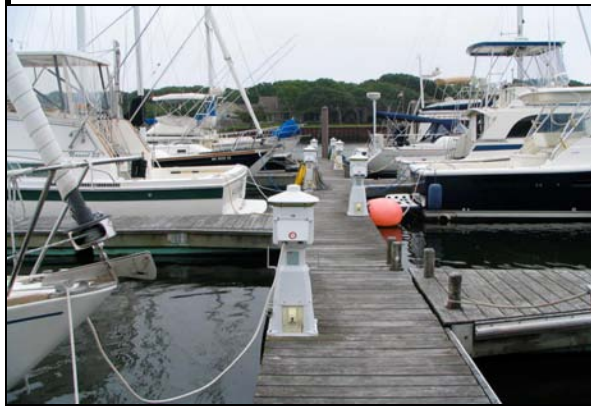
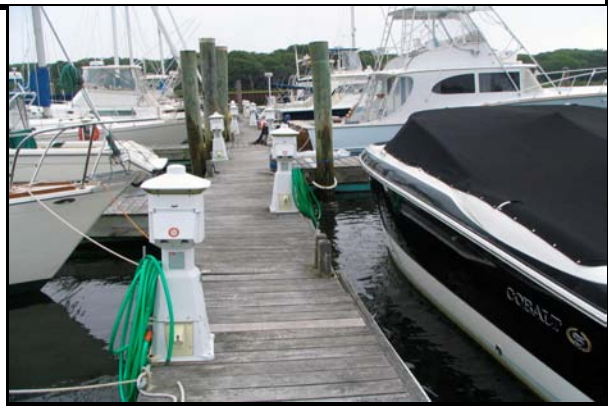
Picture 1

Comments: Typical rust and loose connections, moderate. No extreme need of replacement of any float. Floats C21, C22, C1 and C4 are in need of attention in regard to decking and hardware.

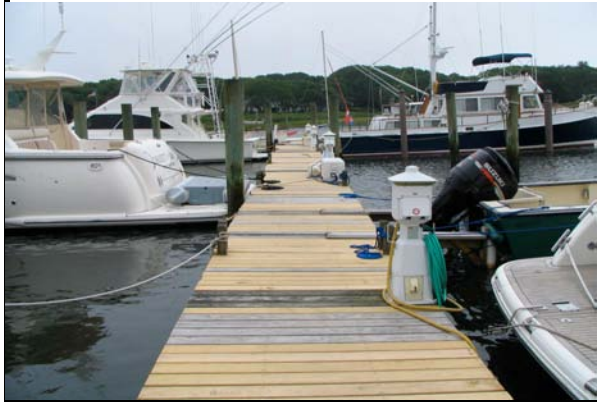
Picture 1

Comments: Majority of floats in fair condition. Decking will need to be replaced within the next 2 years. Sideboards and floating device are in good condition. Total replacement predicted to occur in 5-8 years.

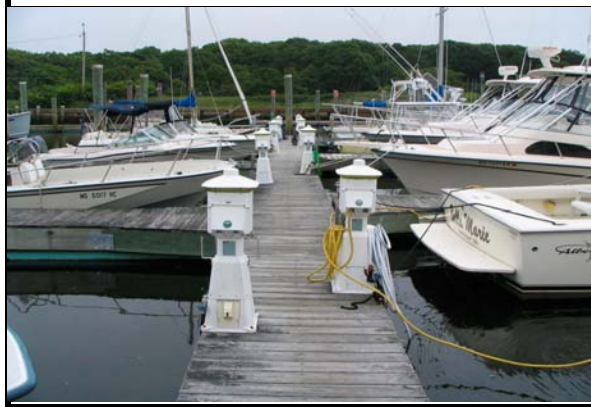
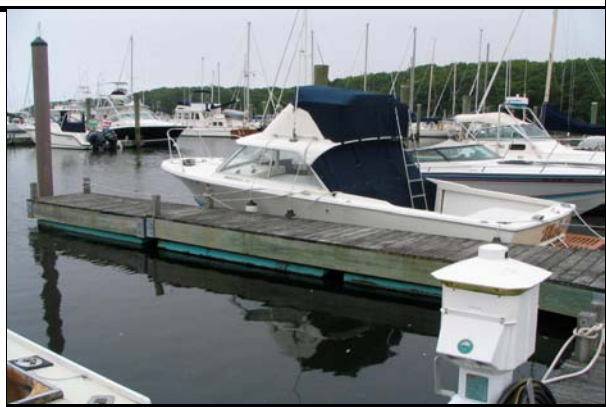
Picture 1

Comments: Floats are in fair shape, predict decking to be replaced within 3 years. Warped connecting bars will need to be replaced - causing floats to be off balace.

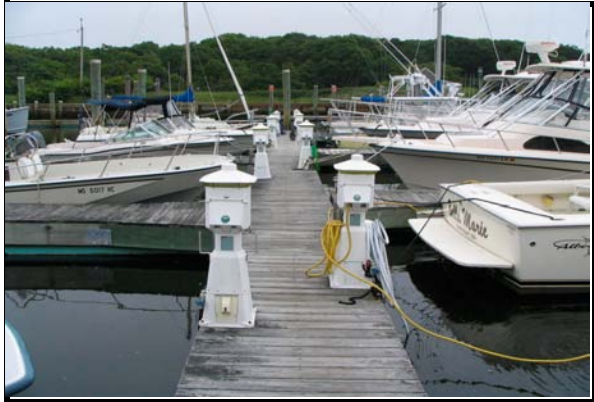
Picture 1

Comments: Majority of floats are in poor condition. Loose and rusted decking that will need to be replaced within 1-2 years. Floatation is adequate.

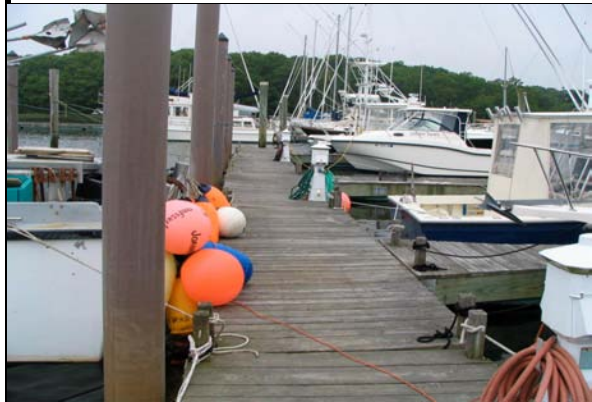
Picture 1

Comments: Decking is splitting and rotting at end sections where nails are rusted. Many areas where decking is loose, no new decking has been installed. Majority of connections in fair shape, no sign of functionality problems. No indication of severe structural damage. Predicted lifespan of 2-3 years until replacement needed.

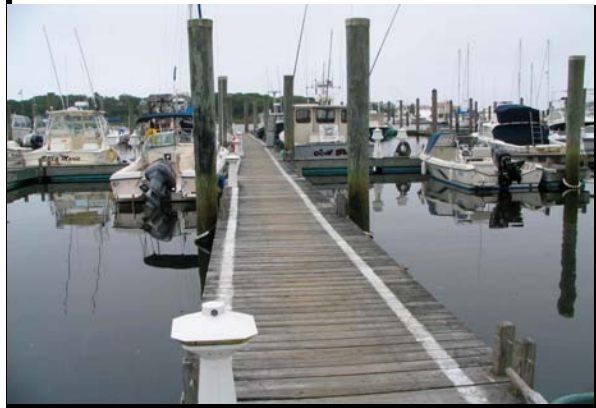
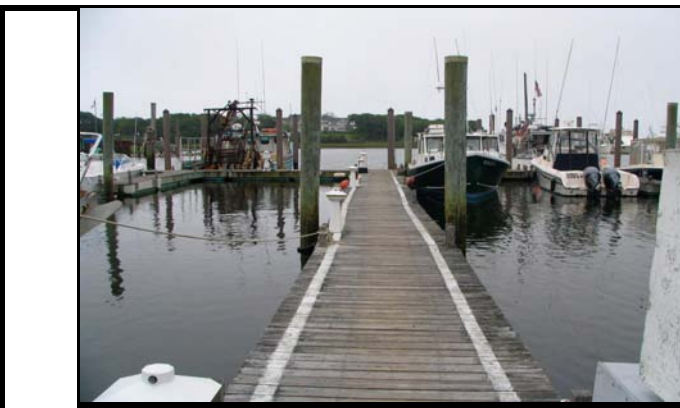
Picture 1

Comments: Rollers between floats warped in multiple locations. Remaining hardware is in good condition. Decking has endured extreme weathering, however side boards are in favorable condition. PT side boards, what about decking? When was decking, floats, sideboards installed?

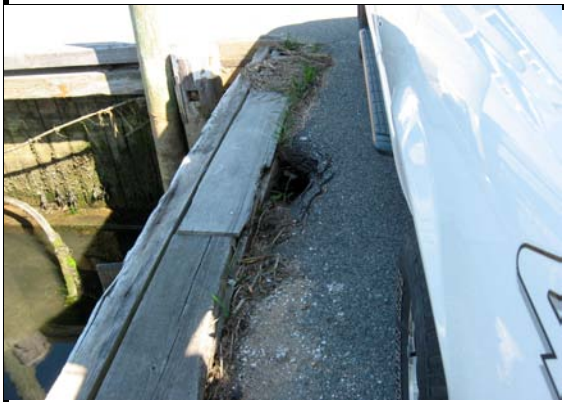
Picture 1

Comments: Overall, wall is in poor condition. Major steel decomposition due to rust and corrosion. Wale showing signs of horizontal checking/splitting due to weathering. Substrate wash out present due to parking lot slumping as seen in Picture 1. New fender piles are not properly secured to wall, recommend to be independent of previous failing fender pile.

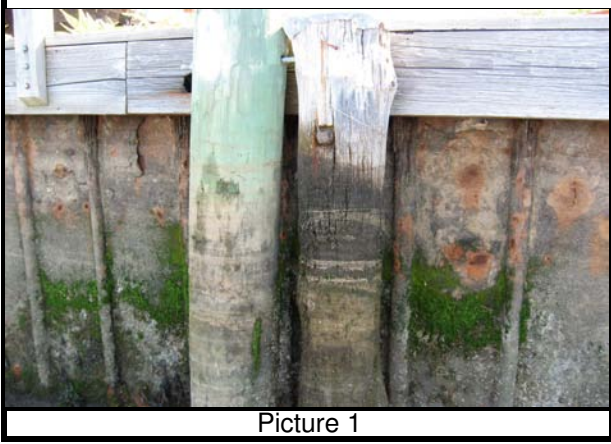
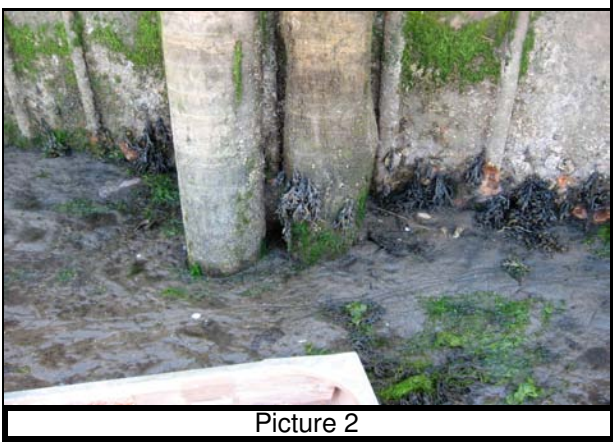
Picture 1

Comments: A2, B2, C2 - major loss @ ground, bolts to wale failed. Connections need to be re-established, piles that are in good condition should be independent of failing piles

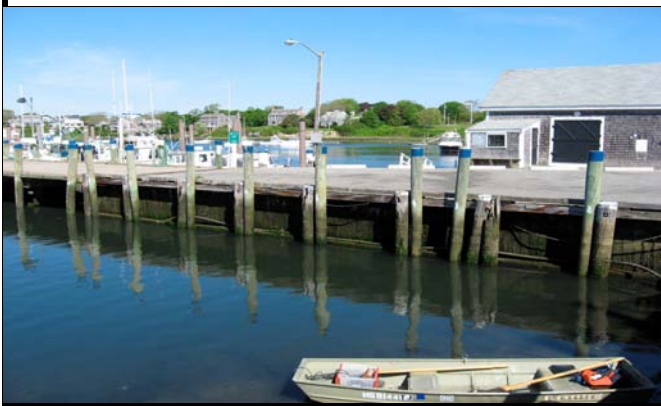
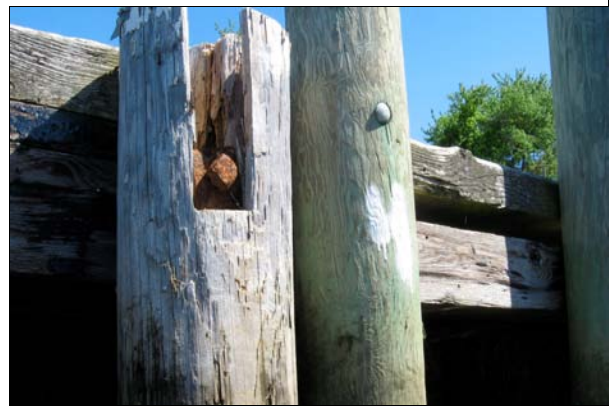
Picture 1

Comments: Majority of supplemental piles are in good condition. Previous piles that still remain are beyond their serviceable life. Connections need to be reinstated in majority of piles, some locations have no bearing capacity due to failed/improper connections.

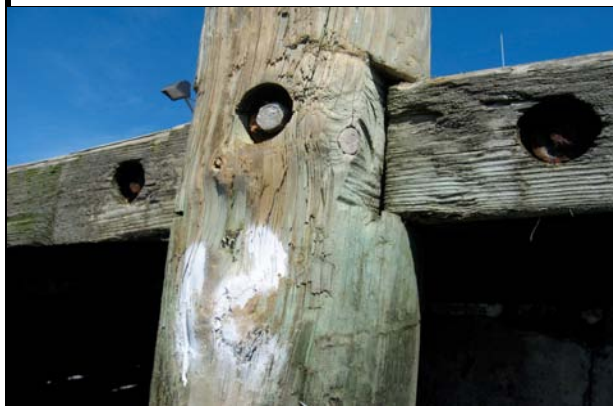
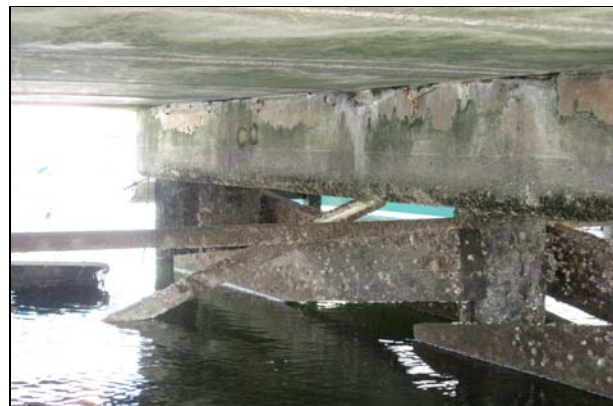
Picture 1

Comments: Fender piles at ends of pier have recently been replaced and are in good working condition. Pier bearing piles that hold load for concrete header beam are in fair to poor condition. Majority of piles are deteriorating (outer shell peeling). Large presence of water being held within the pile, causing accelerated rot and deterioration. Recommend replacement in 2-3 years.

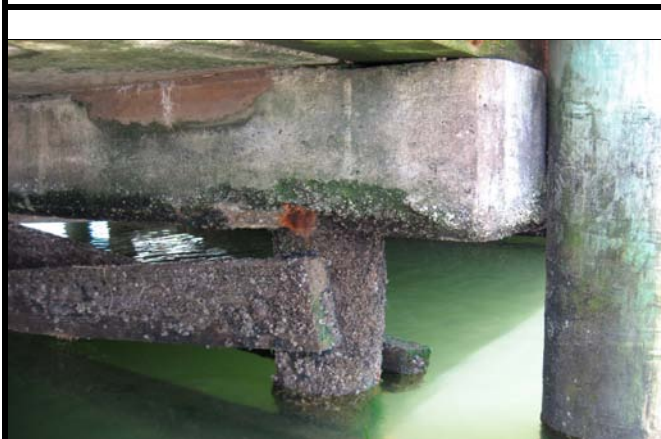
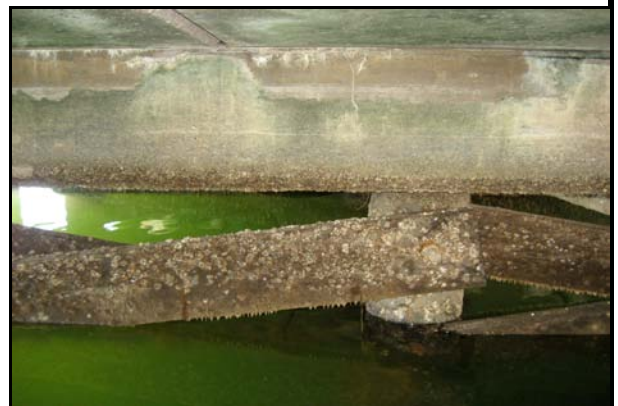
Picture 1

Comments: Fender piles are in good condition. Bearing piles for pier are in fair to poor condition. Recommend replacement within 2-3 years due to outer shell becoming disassociated from pile. The pile is losing it's ability to function properly. Load bearing capacity is decreasing due to section loss of pile.

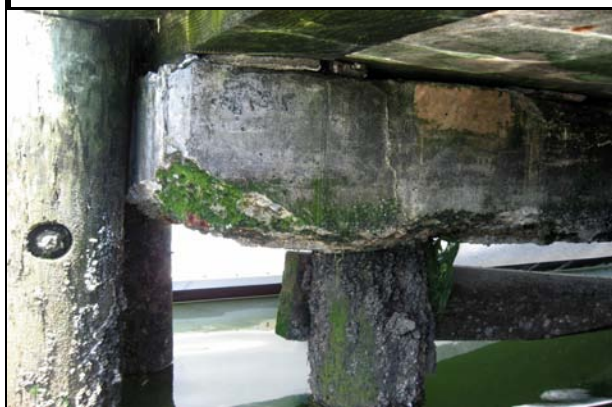
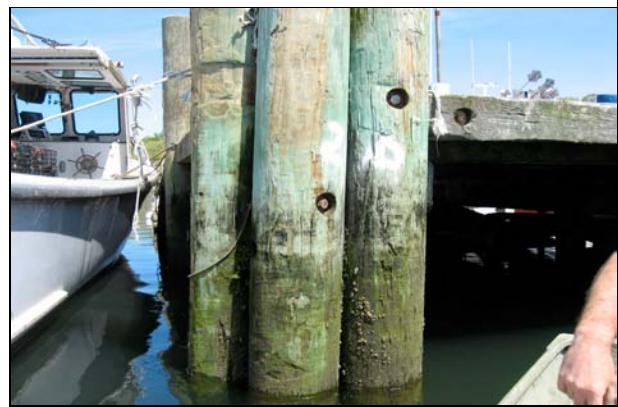
Picture 1

Comments: Piles at end section of pier are in poor condition. Major weathering and insect damage. In addition, bearing piles for pier are in poor condition.

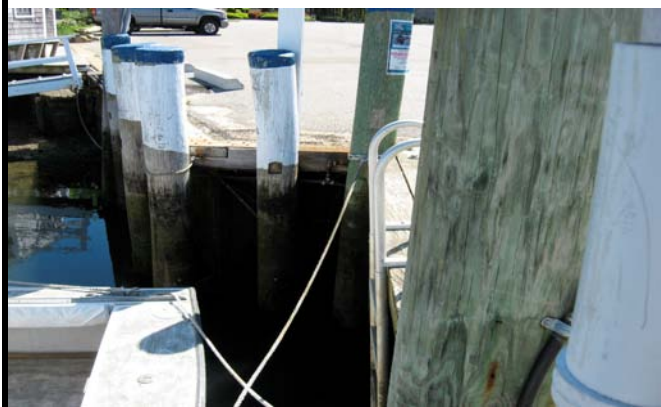
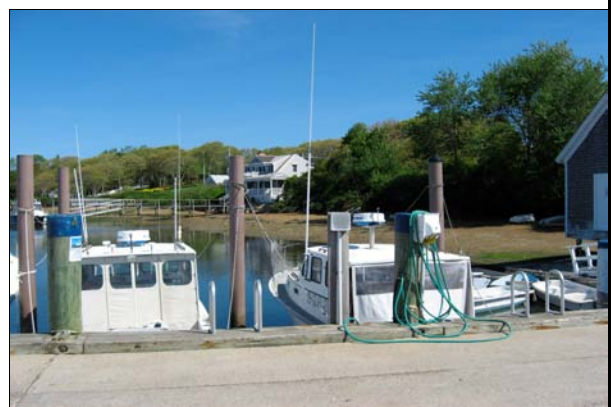
Picture 1

Comments: Majority piles are pearson fiberglass piles that were recently installed. Overall in good condition with minor abrasions caused from boats. Some corrosion/rust at intertidal zone.

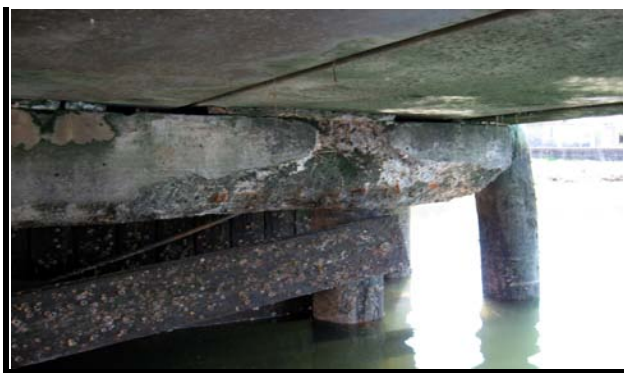
Picture 1

Comments: Concrete header has substantial damage at Bents 1, 3, 4, 5, 6, 7, & 11. Concrete appears to be failing at ends and around bearing piles. Some weathering and spalling present, steel reinforcements exposed with signs of rusting. Possible efflorescence and chemical deterioration due to moisture and poor cement mixtures. Cross bracing members in overall fair shape, bottom horizontal members are in need of replacement. Major sectional loss and rot present. Outer shells of bearing piles are peeling and are becoming disassociated from the pile. Overall, poor condition. Pressure treated fender piles appear to be in moderate-good condition with no major damage present. Connection of fender pile to pier is insufficient (only connected to timber curbing)

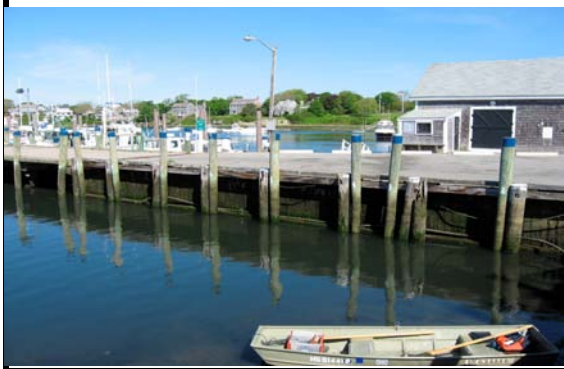
Picture 1

Comments: Wall is in fair condition. Minor striations present, with few voids caused from rot or marine borers. Some deterioration seems to be caused from either birds or insects. 3" dia void between piles 5 & 6. Parking lot showing signs of slumping due to substrate loss at wall. Anchors are substantially rusted, recommend replacement. Previous fender piles have been supplemented with 12" PT pilings, new pilings are in excellent condition, however the single connection to the existing deteriorated pilings is insufficient. New piles should be connected to wall directly, independently from previous piles.

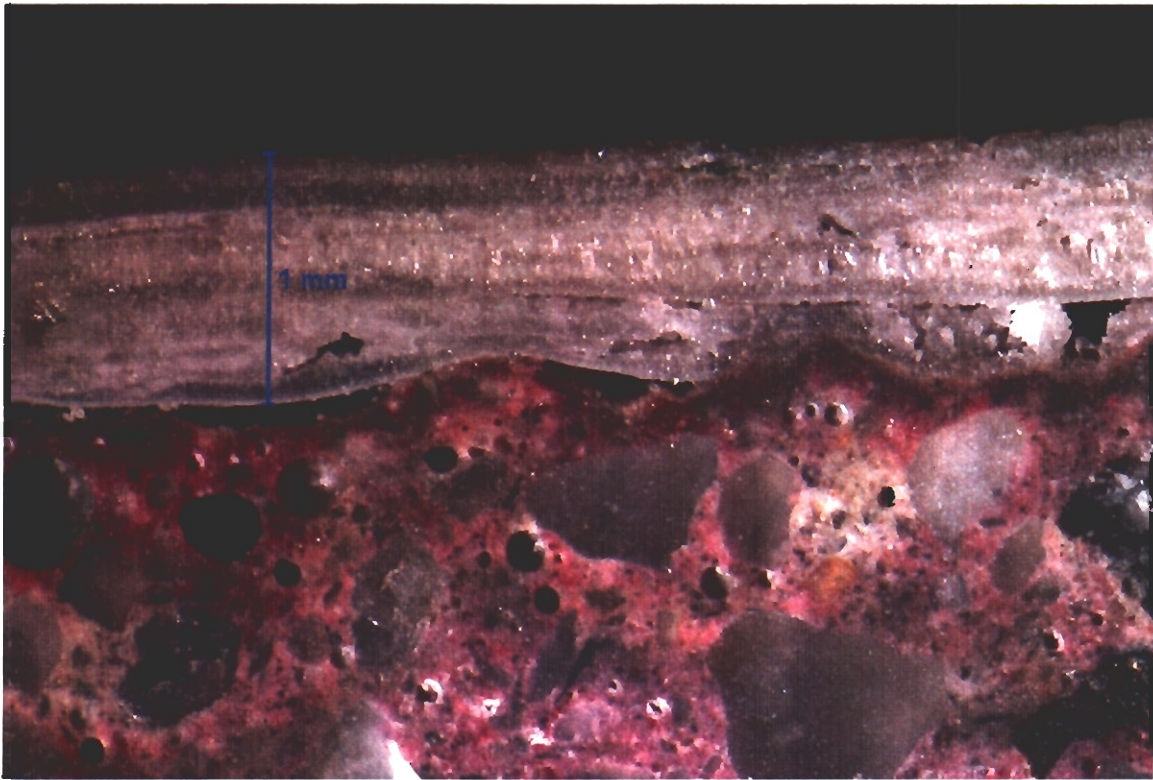
SAMPLE ID: C2
MAG: 30x

DESCRIPTION: Secondary calcite deposit on the outer surface of the sample.

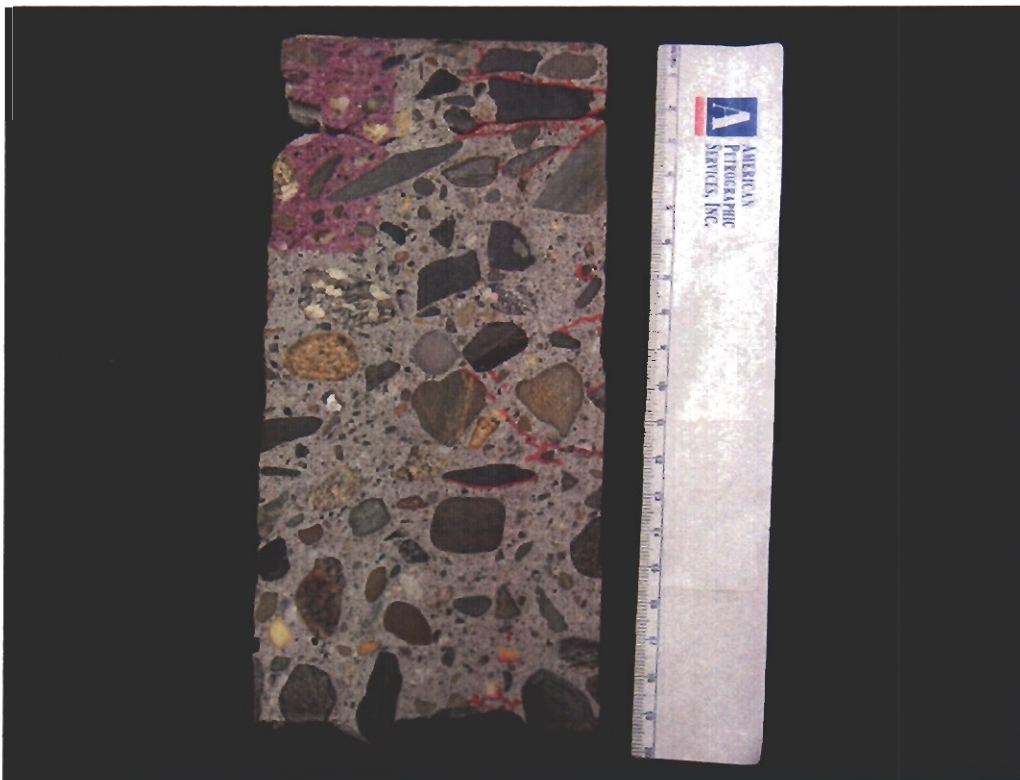
SAMPLE ID: C2

DESCRIPTION: Microcracking (mapped in red) across one half of the cut and polished cross section of concrete.

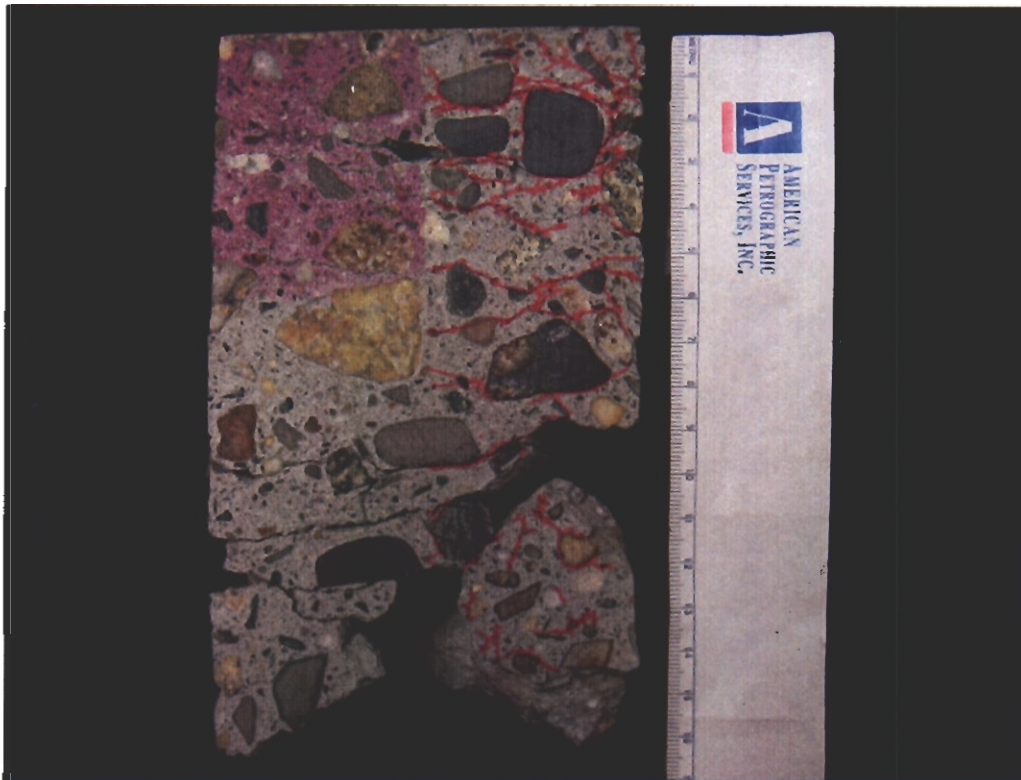
SAMPLE ID: C3

DESCRIPTION: Microcracking (mapped in red) across one half of the cut and polished cross section of concrete. Note the fractures orientated sub-parallel to the outer surface of the sample.

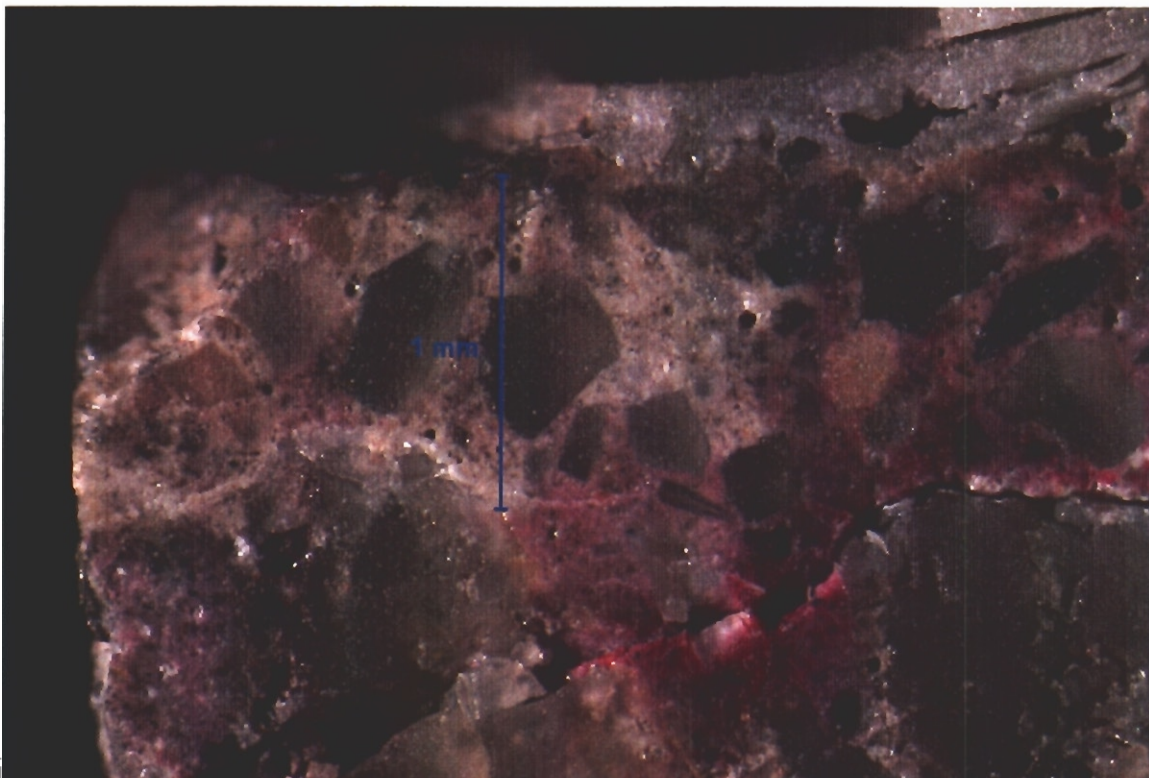
SAMPLE ID: C2
MAG: 30x

DESCRIPTION: Carbonation (unstained) proceeds up to 3 mm (1/8") depth from the outer surface.

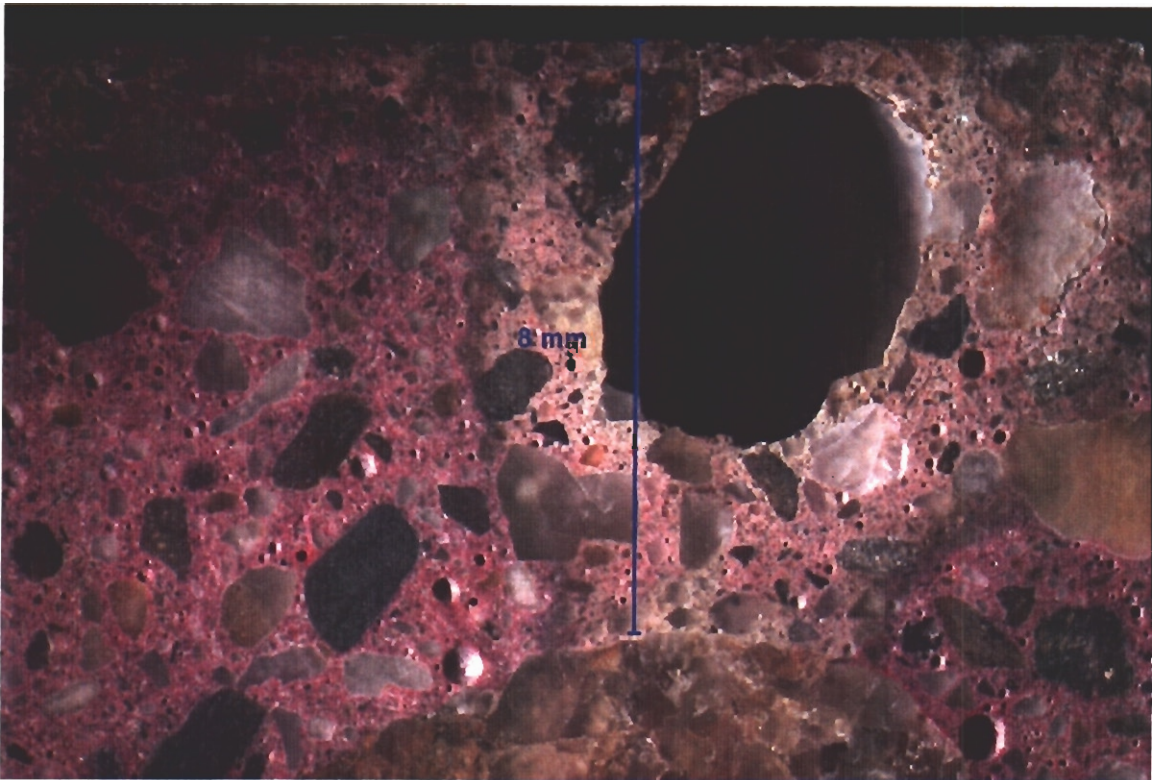
SAMPLE ID: C3
MAG: 10x

DESCRIPTION: Carbonation (unstained) proceeds up to 8 mm (5/16") depth from the outer surface.

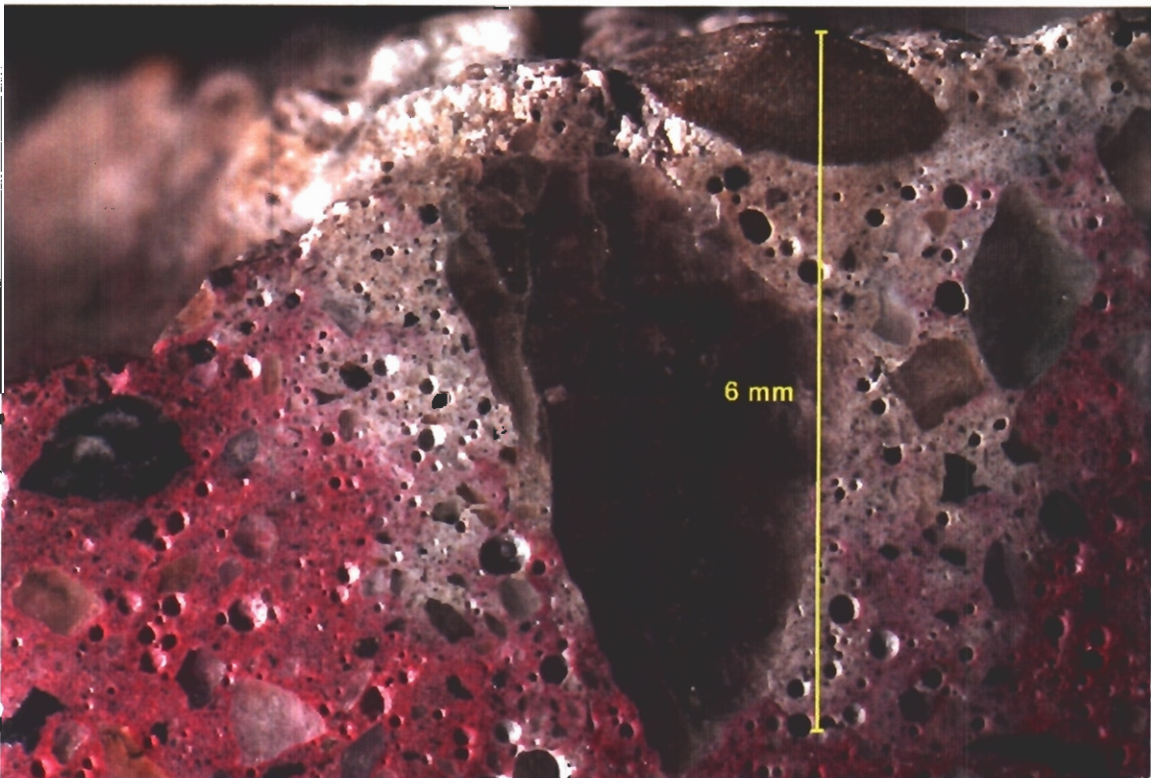
SAMPLE ID: C4
MAG: 15x

DESCRIPTION: Carbonation (unstained) proceeds up to 6 mm (1/8") depth from the outer surface.
