TOWN OF HARWICH HARBORS & MARINE FACILITIES ANALYSIS REPORT

August 19, 2009

Prepared for:
TOWN OF HARWICH
c/o Joe Borgesi, Town Engineer
732 Main St.
Harwich, MA 02645

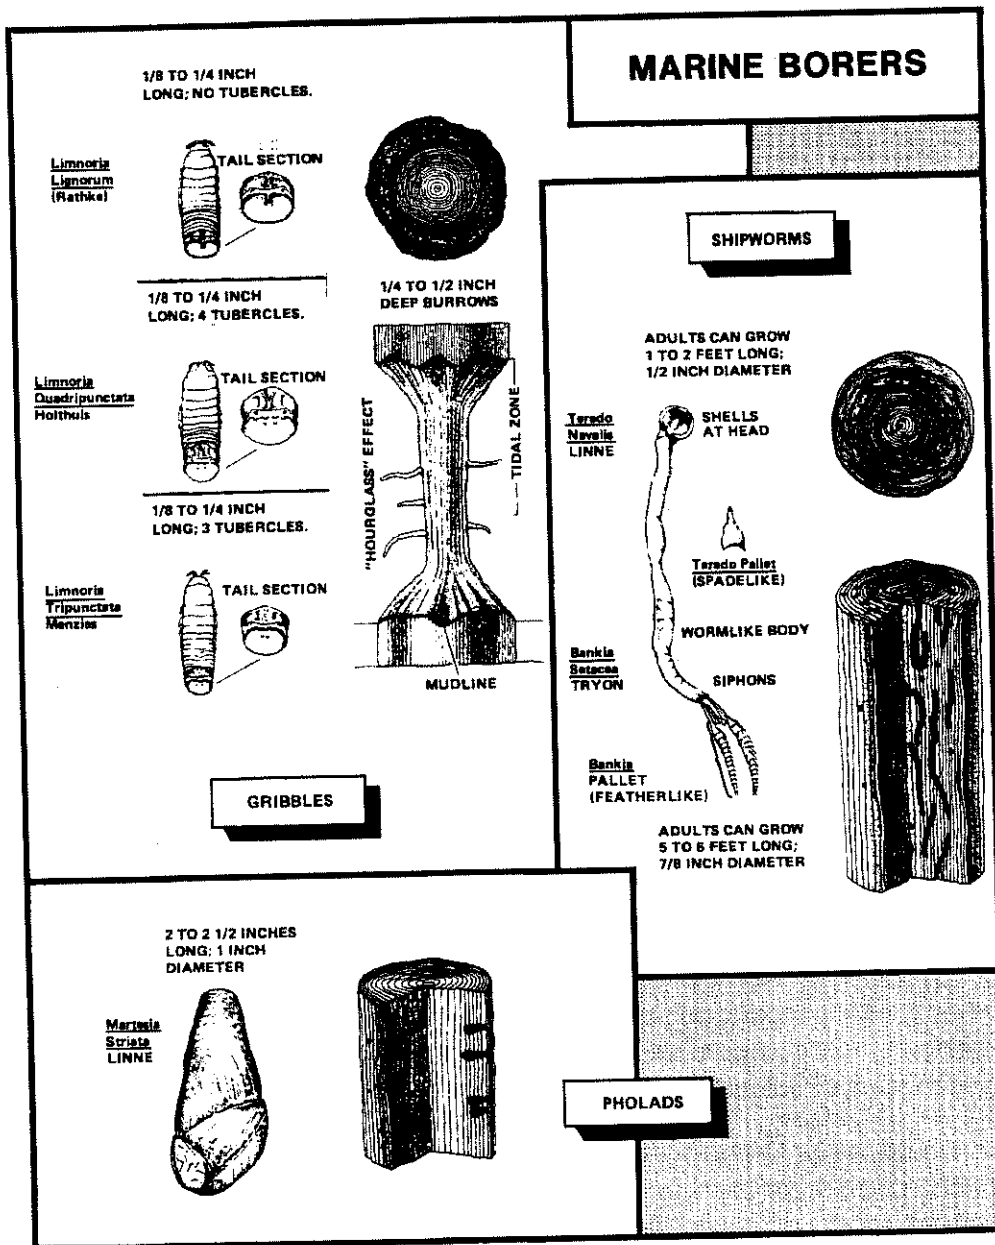
Figure 3-1. Three groups of Marine Borers.¹

NOTE: Gribbles are 3mm to 6mm (1/8 to 1/4 inch) in length; Shipworms are 30 to 60 cm (1 to 2 feet) in length, 12.7mm (1/2 inch) in diameter, and Pholads are 51mm to 63.5mm (2 to 2 1/2 inches) in length.

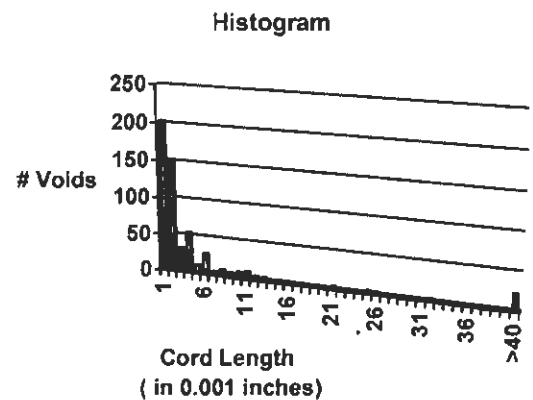
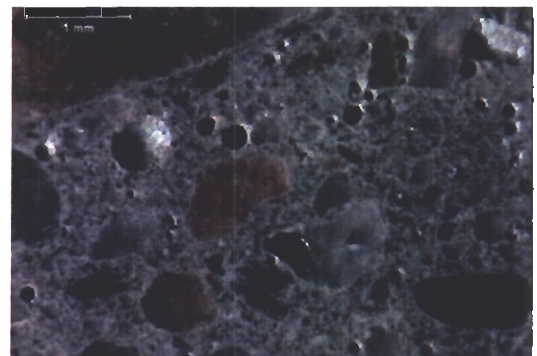
Air Void Content %	4.0
Entrained, % $\leq 0.040''$	2.2
Entrapped, % $> 0.040''$	1.8
Air Voids/inch	6.16
Specific Surface, in ² /in ³	620
Spacing Factor, inches	0.009
Paste Content, % estimated	26.0
Magnification	50x
Traverse Length, inches	90
Test Date	06/25/2009

Magnification: 30x
Description: Overall hardened air content, 4.0% total

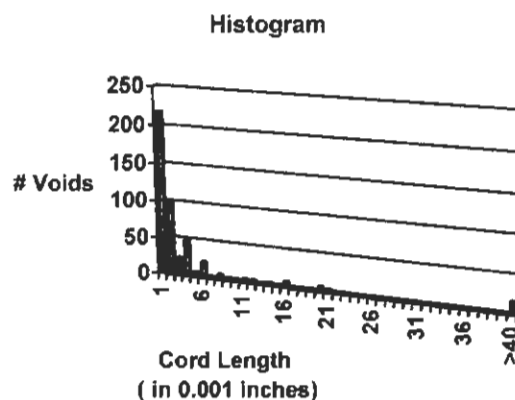
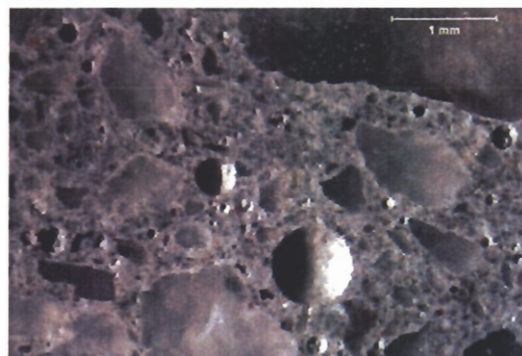
Air Void Content %	3.1
Entrained, % $\leq 0.040''$	1.8
Entrapped, % $> 0.040''$	1.3
Air Voids/inch	5.06
Specific Surface, in ² /in ³	660
Spacing Factor, inches	0.009
Paste Content, % estimated	25.0
Magnification	50x
Traverse Length, inches	96
Test Date	06/29/2009

Magnification: 30x
Description: Overall hardened air content, 3.1% total

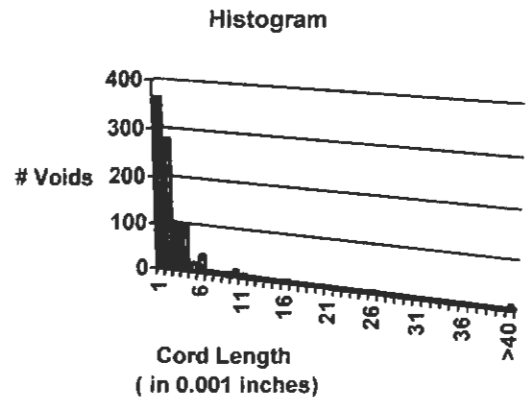
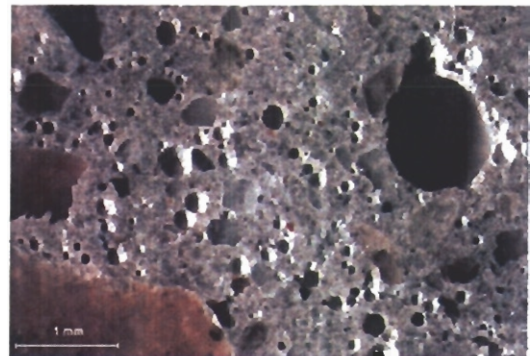
Air Void Content %	3.8
Entrained, % $\leq 0.040''$	3.2
Entrapped, % $> 0.040''$	0.6
Air Voids/inch	10.80
Specific Surface, in ² /in ³	1130
Spacing Factor, inches	0.005
Paste Content, % estimated	27.0
Magnification	50x
Traverse Length, inches	90
Test Date	06/26/2009

Magnification: 30x
Description: Overall hardened air content, 3.8% total

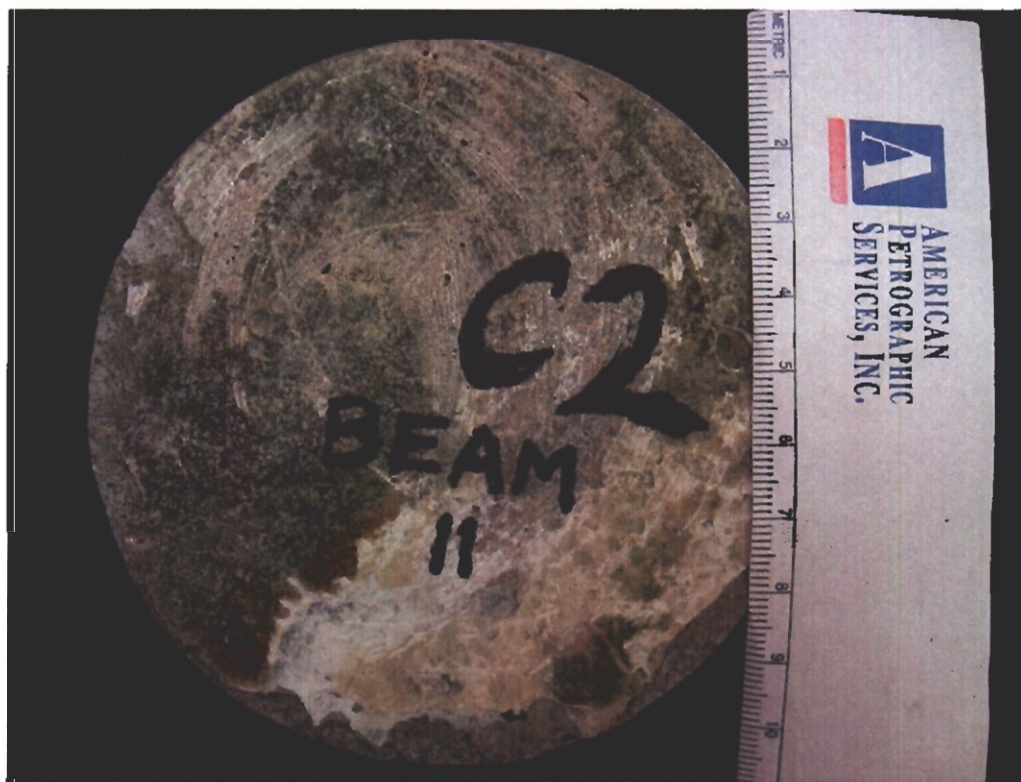
SAMPLE ID: C2 DESCRIPTION: Outer surface of sample as received

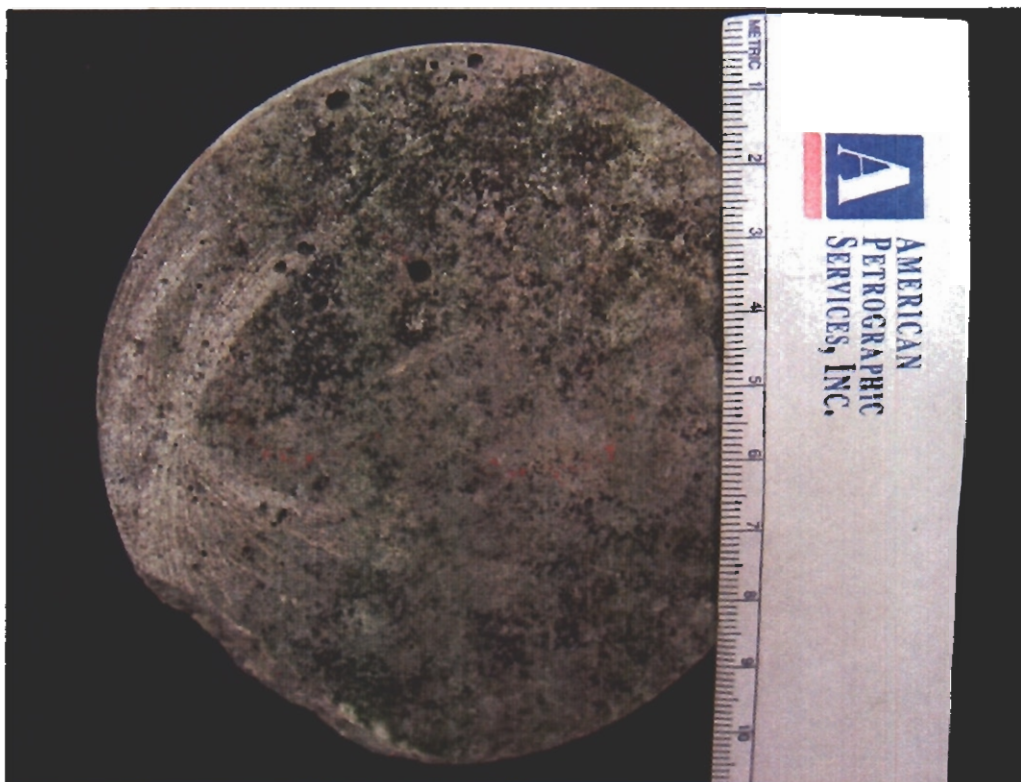
SAMPLE ID: C3 DESCRIPTION: Outer surface of sample as received.

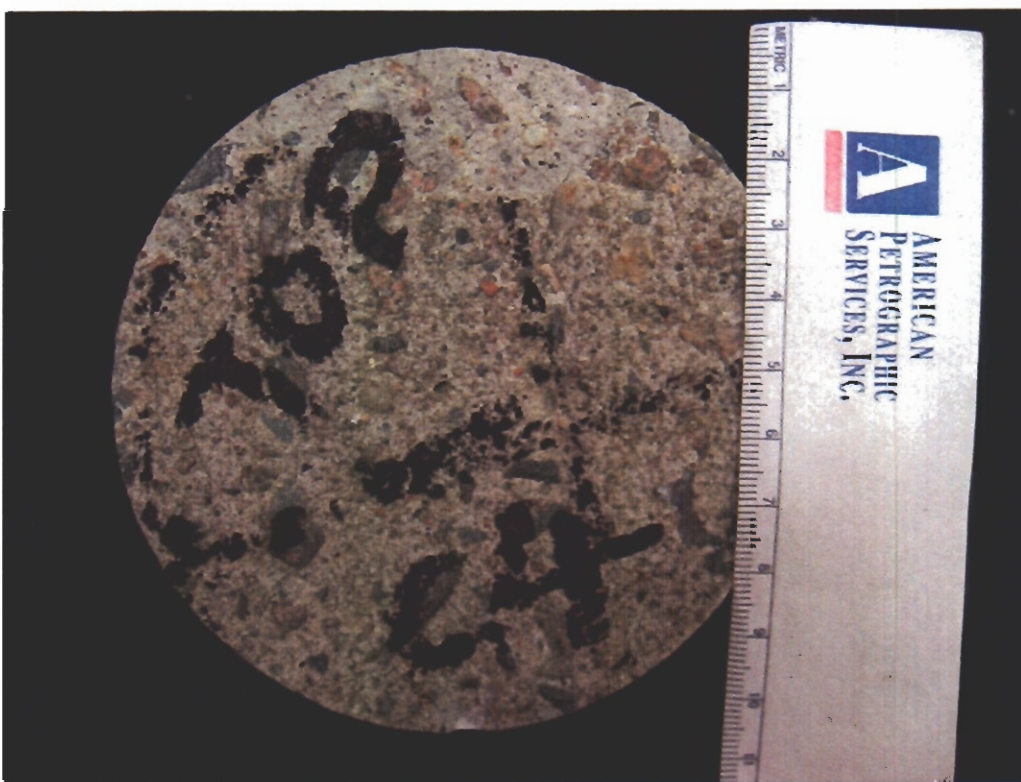
SAMPLE ID: C4 DESCRIPTION: Outer surface of sample as received.

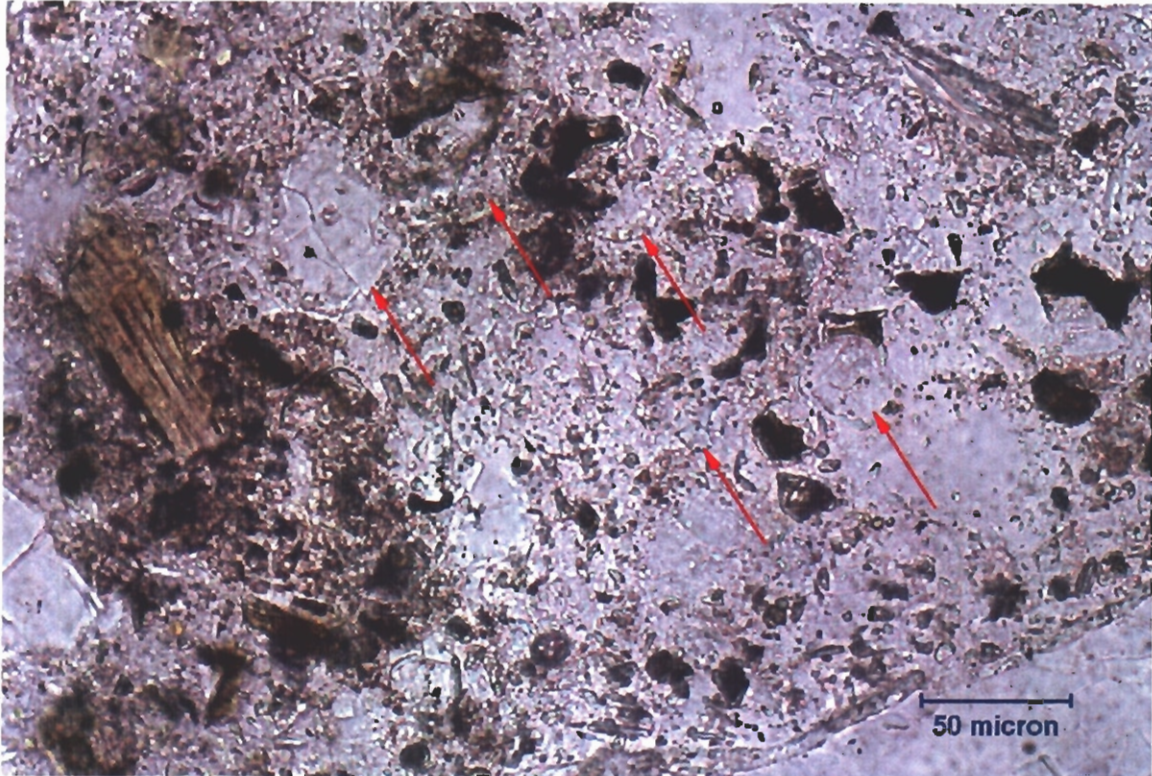
SAMPLE ID: C3
MAG: 400x

DESCRIPTION: Mostly fully hydrated alite portland cement clinker particles (red arrows) in thin section of the cement paste under plane polarized light.

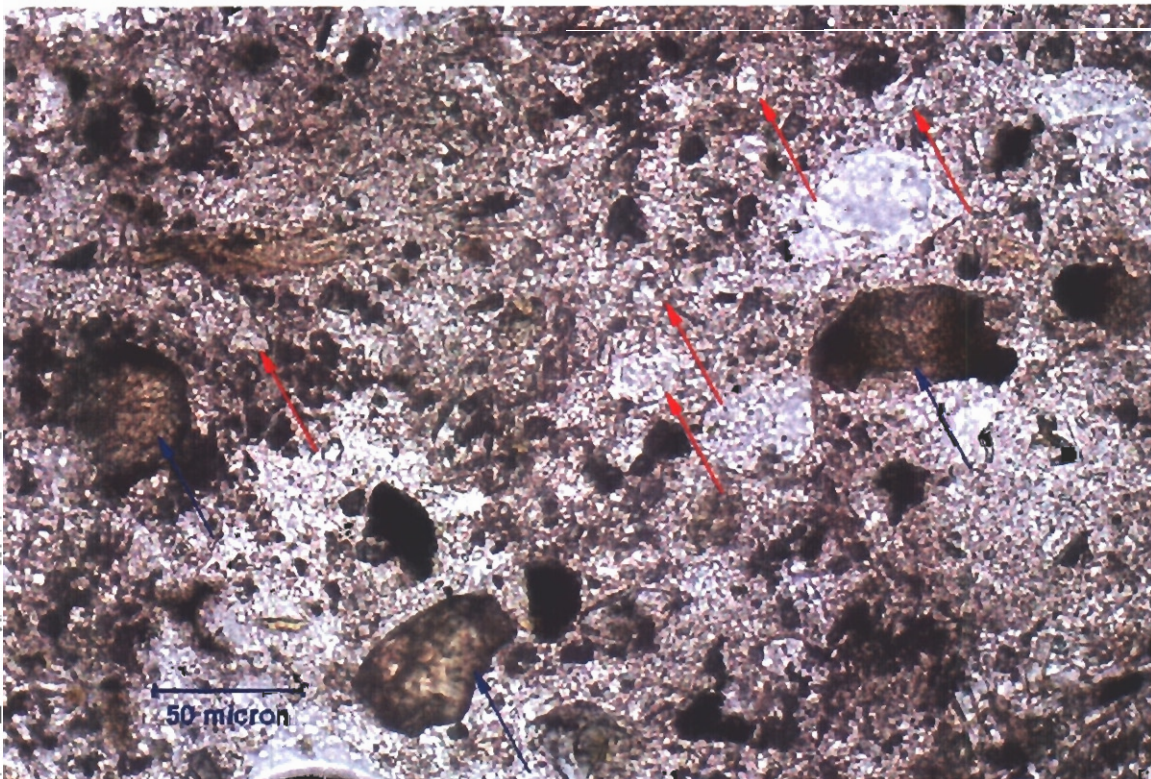
SAMPLE ID: C4
MAG: 400x

DESCRIPTION: Mostly fully hydrated alite portland cement clinker particles (red arrows) and poorly hydrated belite particles (blue) in thin section of the cement paste under plane polarized light.
